BELZONA® 1391 PROTECTS JUICE HEATER END COVER

ID: 225

Industry: *Sugar*
Application: *HEX-Heat Exchangers*
Substrate: *Cast iron*
Products: ** Belzona® 1391 ,*

Customer Location: *Sugar factory in Ireland*
Application Date: *1999*

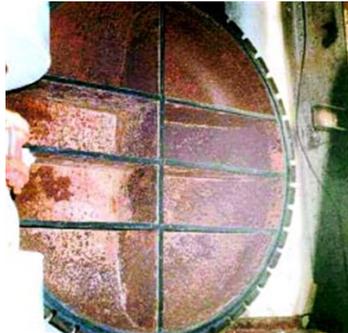
Extensive corrosion pitting.

- * General view of the application site ,
- * Equipment prior to surface preparation ,
- * Application completed with Belzona® 1391 ,

The end cover of a juice heater.

The application was carried out in accordance with Belzona Know-How System Leaflets HEX-2.

Corrosion of the end cover if allowed to continue would have led to the operating efficiency of the juice heater being impaired. Belzona® 1391 was found after testing to be the only product to protect the cover at the operating temperature of 80°C.
