BELZONA REFURBISHES EIGHTY YEAR OLD TURBINE RUNNER

ID: 2254

Customer Location: Hydro-electric plant, Arkansas
Application Date: 2008

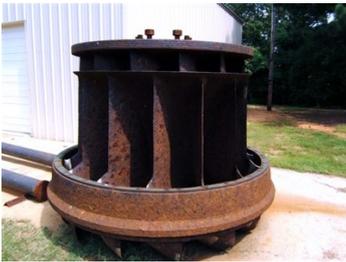
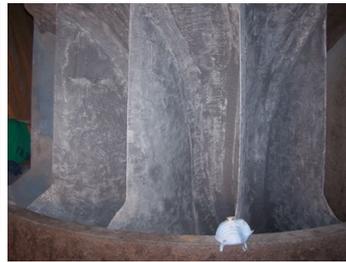
Years of use had caused severe corrosion and cavitation erosion on the turbine. Customer had received bids for new replacement but chose Belzona on economic grounds.

- * Turbine before initial blast cleaning ,
- * Some of the cavitation damage ,
- * Project after Belzona® 1121 application ,
- * Completed project ,

Severely eroded Francis turbine runner.

Application was carried out in accordance with Belzona Know-How System Leaflets CEP-3 & CEP-5. Corroded surfaces were rebuilt and smoothed with Belzona® 1121 before coating with Belzona® 1341 for long term protection.
