# BELZONA REFURBISHES EIGHTY YEAR OLD TURBINE RUNNER

ID: 2254

**Customer Location:** Hydro-electric plant, Arkansas  
**Application Date:** 2008

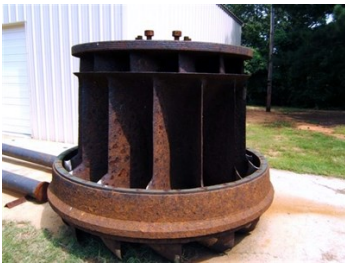
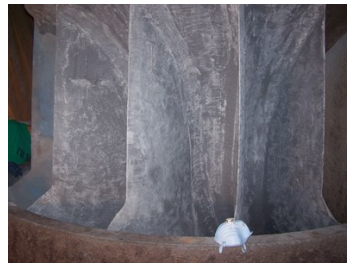
*Years of use had caused severe corrosion and cavitation erosion on the turbine. Customer had received bids for new replacement but chose Belzona on economic grounds.*

- \* Turbine before initial blast cleaning ,
- \* Some of the cavitation damage ,
- \* Project after Belzona® 1121 application ,
- \* Completed project ,

Severely eroded Francis turbine runner.

Application was carried out in accordance with Belzona Know-How System Leaflets CEP-3 & CEP-5. Corroded surfaces were rebuilt and smoothed with Belzona® 1121 before coating with Belzona® 1341 for long term protection.
