BELZONA REPAIR AND PROTECTION OF SEA WATER LIFT PUMPS

ID: 2257

Customer Location: Pump repair workshop, Norway
Application Date: September 2010

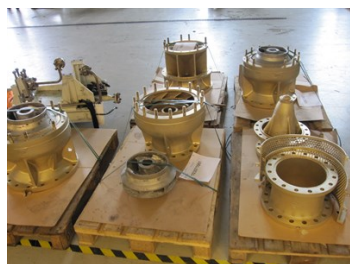
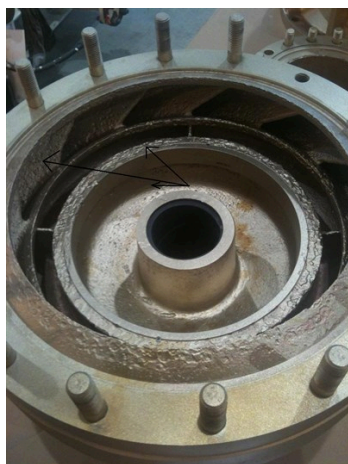
Pumps and various assembly parts were suffering from erosion and corrosion.

- * Application parts overview ,
- * Close up of corroded surface ,
- * Rebuilding with Belzona® 1311 ,
- * Complete application with 2 coats of Belzona® 1341 ,

Application was carried out in accordance with Belzona Know-How System Leaflets CEP-3 & CEP-5.
