# BELZONA PROTECTION OF RISER BEND

**Industry:** Oil & Gas  
**Application:** VPF-Valves, Pipes and Fittings  
**Substrate:** Aluminium Bronze  
**Products:** \* Belzona 1311 (Ceramic R-Metal) ,  
\* Belzona 1321 (Ceramic S-Metal) ,

**Customer Location:** North Sea, Norway  
**Application Date:** January 2011

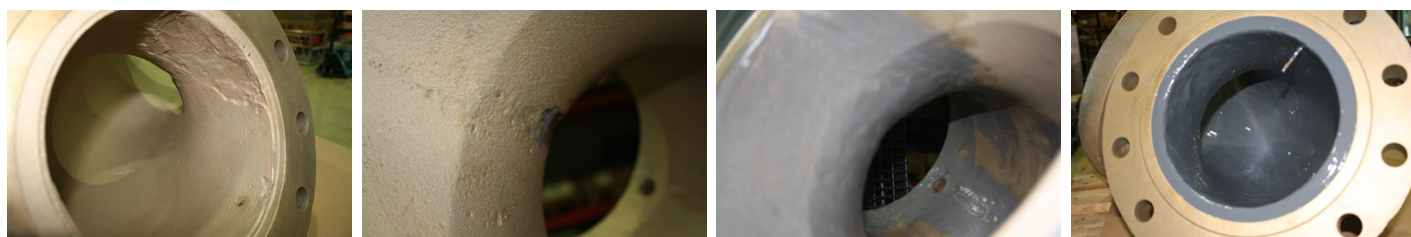
The riser bend was suffering from internal erosion corrosion.

- \* Riser bend overview ,
- \* Internal Erosion Corrosion ,
- \* Corroded areas rebuilt with Belzona® 1311 ,
- \* Application completed with Belzona® 1321 applied ,

Application was carried out in accordance with Belzona Know-How System Leaflet VPF-1 & VPF-2. Following gritblasting all corroded areas were rebuilt using Belzona® 1311. Two coats of Belzona® 1321 were then applied to complete the application.
