BELZONA LOBE REPAIRS AVOID DELAYS

ID: 2272

Industry: Water / Wastewater
Application: PDP-Positive Displacement Pumps

Customer Location: Water treatment plant, Canada
Application Date: February 2001

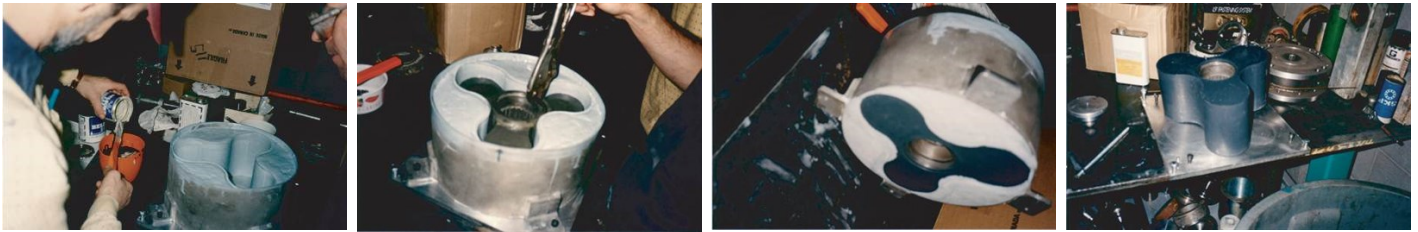
Photograph Descriptions

the rubber lobes wear but there is a delay of 4-6 weeks for the delivery of these lobes.

- * Preparation of the mould coated with Belzona® 1341 ,
- * Lobe position in the mould ,
- * The newly cast lobe in the mould ,
- * The lobe is ready to be back in service. ,

The application was carried out in accordance with Belzona Know-How System Leaflet PDP-9. A mould, lined with Belzona® 1341 was created from new lobes and used to cast replica lobes using Belzona® 2131 around the steel centres which are grit blasted to achieve maximum adhesion.
