# BELZONA RESTORES HEAT EXCHANGER

ID: 2273

**Customer Location:** Governmental building, Canada  
**Application Date:** May 2002

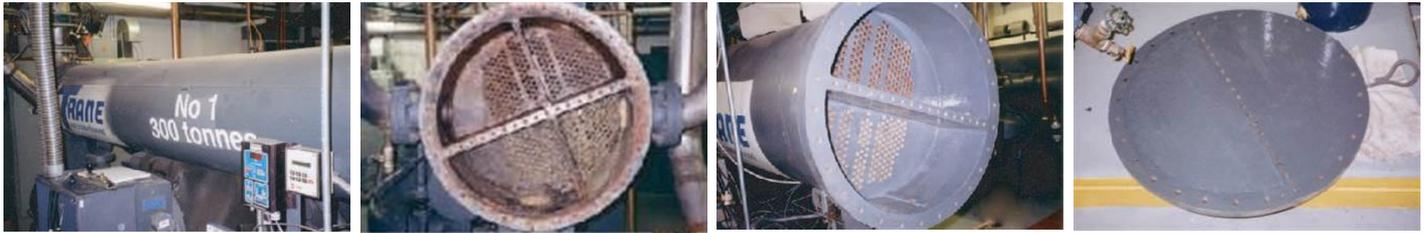
Galvanic corrosion on internal surfaces, particularly tube sheet and end covers.

- \* Overview of the heat exchanger ,
- \* Internal aspect of the heat exchanger before protection ,
- \* Final result after the application of the Belzona coating ,
- \* Cover plate protected with Belzona ,

In less than 5 days, the tube plates and end covers were refurbished, saving thousands of dollars over the purchase of new equipment.
