BELZONA REPAIRS PIPES TRANSPORTING SULFURIC ACID

ID: 232

Customer Location: Refinery in Minnesota, U.S.A.
Application Date: 1996

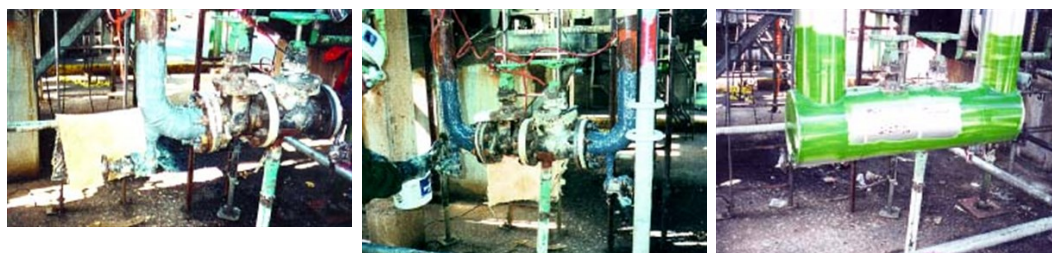
Photograph Descriptions

- * Following surface preparation by cleaning, Belzona® 4301 was applied with reinforcement tape ,
- * Finishing touches with a top coat of Belzona® 4311 ,
- * Finished job ,

Thin spots were detected on the pipe by UT inspection. The pipe required reinforcement.

Pipe carrying sulfuric acid at 80 psi.
