BELZONA REPAIRS FAN AT PULP AND PAPER MILL

ID: 235

Customer Location: *Pulp and paper mill - South Africa*
Application Date: *March 2001*

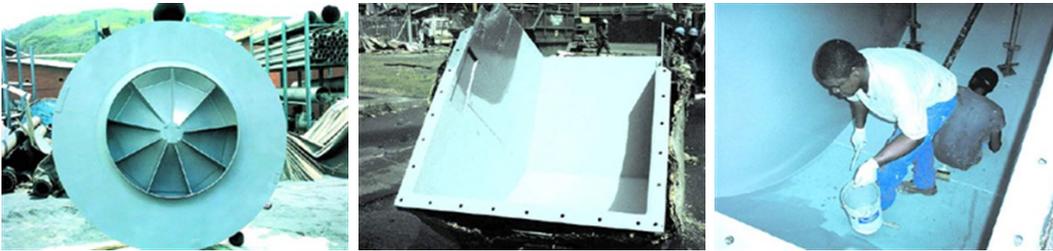
Photograph Descriptions

Magnesium Oxide fan and casing were being destroyed by a serious corrosion/erosion cycle. The process temperature was 150-165C. Although the process is dry, moist air was being sucked in through the shaft hole, corroding the steel.

- * The fan has been grit blasted and is ready to be coated ,
- * The top of the fan casing has been coated with Belzona® 6111 (Liquid Anode) ,
- * Belzona® 5111 (Ceramic Cladding) is being applied to the fan casing bottom ,

An imitation product had been previously used and only lasted for 10-12 months. The engineers chose Belzona for a more long lasting, cost effective solution for the fan and casing. The fan blades were coated with Belzona® 1391 for outstanding erosion/corrosion protection.
