# BELZONA ALL THAT ITS CRACKED UP TO BE

Industry: Sugar  
Application: TCC-Tanks and Chemical Containment Areas  
Substrate: Concrete  
Products: \* Belzona® 4111 ,  
\* Belzona® 4911 ,

Customer Location: Sugar beet mill - Minnesota, U.S.A.  
Application Date: 1992

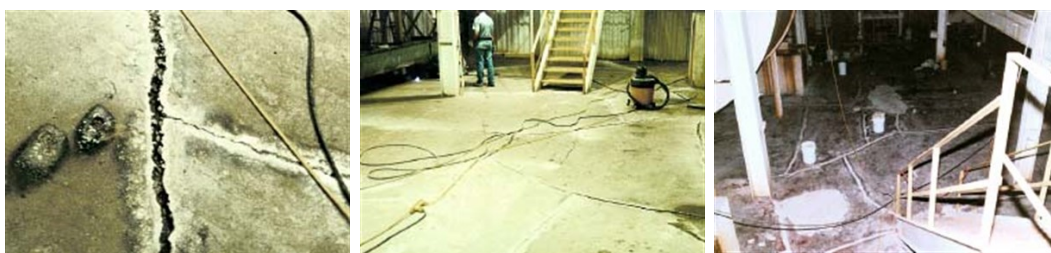
Raw sugar and ambient moisture create an erosive environment over the concrete surface. Over time, the floor's surface spalls and creates safety hazards.

- \* View of damaged floor ,
- \* Cracks are being V-cut and terminated ,
- \* Spalled area and cracks have been repaired with Belzona® 4111 ,

The application was carried out in accordance with a modified version of Belzona Know-How System Leaflets TCC-1 and TCC-9.
