BELZONA LEVELS LOADING QUAY

ID: 2365

Industry: *Buildings & Structures*
 Application: *FPA-Floor Problem Areas*
 Substrate: *Concrete*
 Products: ** Belzona® 4111 (Magma-Quartz),*

Customer Location: *Animal feed manufacturer, Canada*
 Application Date: *November 2006*

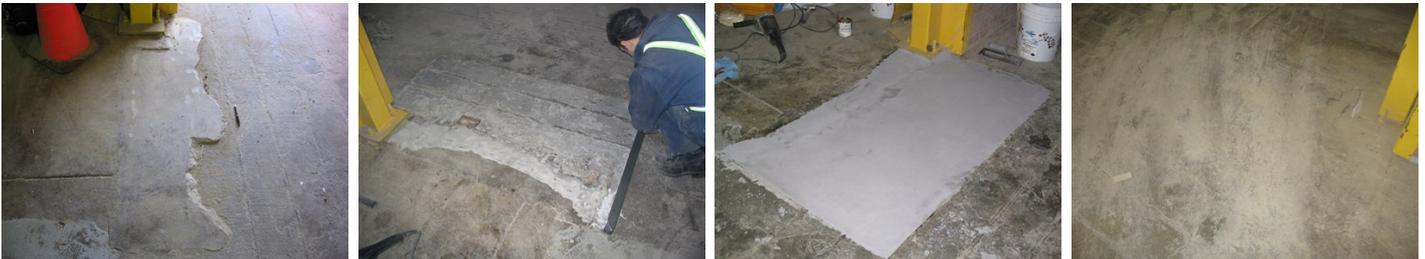
Photograph Descriptions

The uneven surface (measuring 1 inch) between two concrete sections was causing impact problems to forklift trucks driving through. The impact caused pain to the personnel operating these trucks, as well as jeopardising the balance and security of the loads.

- * The failed previous alternative repair ,
- * Surface preparation ,
- * Completed application ,
- * Application after 1 year ,

A less costly alternative repair had lasted only 6 month (picture 1). Belzona 4111 is still intact after 1 year in service, due to its excellent bond strength, impact resistance and compressive strength.

The application was carried out in accordance with Belzona Know-How System Leaflet FPA-1.
