BELZONA REJUVENATES STEEL PLANT ACID & CAUSTIC BUNDS

Industry: General Industry
Application: TCC-Tanks and Chemical Containment Areas
Substrate: Concrete
Products: * Belzona® 4131 (Magma Screed) ,
* Belzona® 4311 (Magma CR1) ,

Customer Location: Steel Plant, Teesside, UK
Application Date: 2011

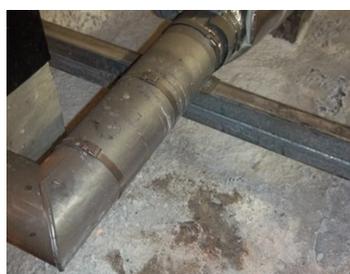
The two bund areas needed complete refurbishment. Over the years acid and caustic residues had attacked the bunds and left them both badly deteriorated. The client wanted the area cleaned and protected with a material that would resist further attack.

- * Original condition with Acid & Caustic attack ,
- * Fillet created in Belzona® 4131 ,
- * Finished system in Belzona 4311 ,
- * Acid and Caustic bunds completed in Belzona® 4311 ,

Application was carried out in accordance with Belzona Know-How System Leaflet TCC-15. A 25mm fillet of Belzona® 4131 was installed on internal angles before applying the Belzona® 4311 system.
