BELZONA SEALS EXPANSION JOINTS

ID: 238

Customer Location: Sugar Beet mill in Minnesota, U.S.A.
Application Date: 1991

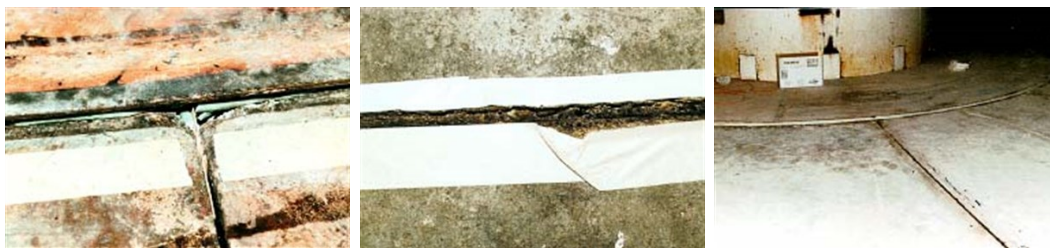
Photograph Descriptions

Contact with chemicals and sugar juice deteriorate expansion joint sealing material.

- * Severely damaged expansion joints ,
- * Cleaned and prepared expansion joint before the use of Belzona® 2221 ,
- * Successfully sealed expansion joints ,

The application was carried out in accordance with a modified version of Belzona Know-How System Leaflets FPA-6.
