BELZONA REVIVES 'MOTH-BALLED' POWER PLANT

Application: HEX-Heat Exchangers

A corroded 70-year-old cast iron water box.

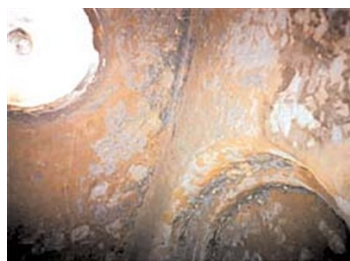
The power plant was sold under California's power industry de-regulation and was scheduled to be dismantled. The current energy crisis caused it to be called back on line, however, the water box for two of the units was severely corroded on the inside.

- * View of severe corrosion on the interior ,
- * Rebuilding with nearly 1/8" of Belzona® 1121 over the entire surface of about 2,500 square feet ,
- * Coating with Belzona® 5811 ,
- * Sealing edges of box to tube sheet with Belzona® 2211 ,

The application was carried out in accordance with Belzona Know-How System Leaflets HEX-2, HEX-3 and HEX-5.
