# BELZONA® 5811: EXCEEDING WHERE OTHERS FAIL

Industry: Power  
Application: HEX-Heat Exchangers  
Substrate: Carbon steel  
Products: \* Belzona® 5811 (Immersion Grade) ,

Customer Location: Gas-fired power plant in Midwest, U.S.A.  
Application Date: March 2000

G.E. Condenser (Generator) Water Box

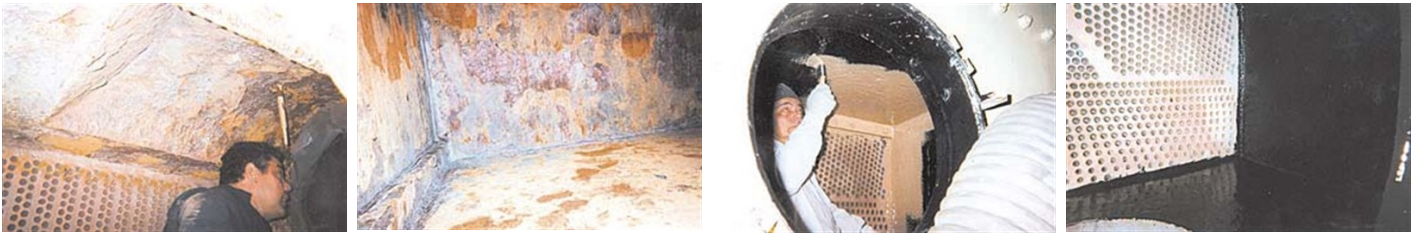
Previous coatings had failed in a very short time. Loss of imitator coating and severe corrosion were causing the blockage of tubes, thus reducing efficiency of unit.

- \* Corroded water box ,
- \* Another view of the corrosion ,
- \* Belzona® 5811 was brush applied in a two coat process - black over tan ,
- \* Completed application of Belzona® 5811 ,

The application was carried out in accordance with Belzona Know-How System Leaflet HEX-3.

After one year of service, only minor touch-ups were required. The power plant superintendent is a very happy customer and the job has led to other applications.
