# BELZONA STORAGE TANK PATCH REPAIR

ID: 2404

Customer Location: Energy Provider, USA  
Application Date: April 2009

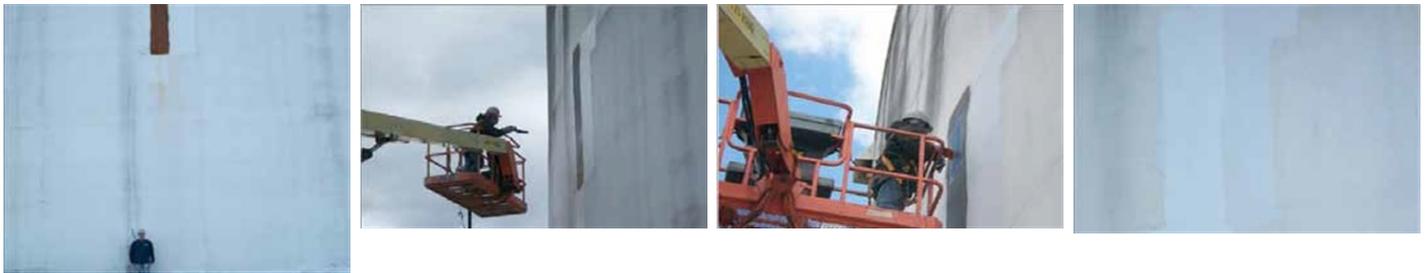
## Photograph Descriptions

A vertical weld was found to be porous and product was weeping from a tiny porous spot less than 2mm in diameter. There was no corrosion or thin walling. The defect was located at the 30' level of a 56' high tank. The client needed the tank to be back in service as soon as possible.

- \* Defect prior to repair ,
- \* Repair area prepared by abrasive blasting ,
- \* Application of Belzona® SuperWrap patch ,
- \* Belzona® SuperWrap patch inspected and painted ,

The defect was sealed using a Belzona® SuperWrap patch and the repair was continued vertically along the entire length of the weld as a precaution. Belzona's compliant, engineered repair enabled the client to eliminate the need for hot work on the tank, which was a safety concern. This approach also minimized the time the tank was out of service. The tank was repaired, inspected, and ready for service within three days. Furthermore, the tank was back to full height of product three weeks later with successful

results. The Belzona repair is compliant to ISO/TS 24817, DOT Title 49, Chapter 1, Part 192, and ASME PCC-2 Article 4.1 standards and as such provides a permanent, reinforced, composite repair to the tank.
