BELZONA CRUSHES ANOTHER PROBLEM

Industry: *Mining & Quarrying*
Application: *MPT-Mechanical Power Transmission*

Customer Location: *Quarry, Kansas U.S.A.*
Application Date: *June 1999*

Substrate: *Stainless steel*
Products: ** Belzona® 1121 (Super XL-Metal) ,*

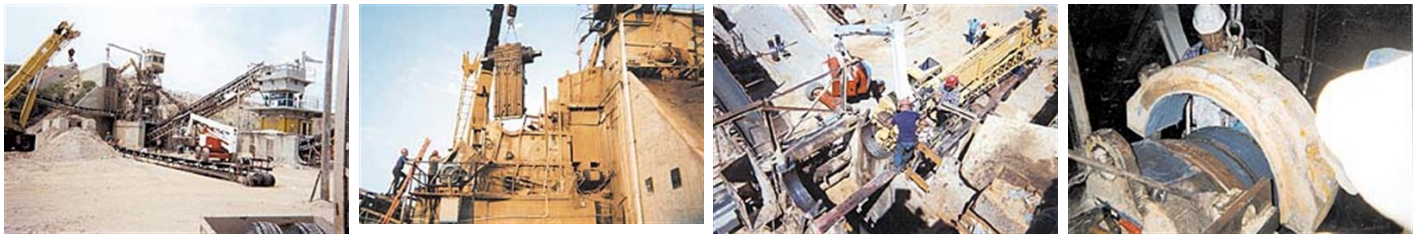
Photograph Descriptions

During a maintenance outage, the plants 34-ton rock crusher's main bearing saddles were showing unacceptable levels of wear.

* An overview of the quarry An overview of the rock crusher The Belzona® 1121 (Super XL-Metal) being applied The equipment being reassembled ,

The application was carried out in accordance with Belzona Know-How System Leaflet MPT-7 using Belzona® 1121 (Super XL-Metal) due to the extreme summer heat and long time required to "reset" the equipment via crane.
