PROTECTION COATING APPLICATION ON A BULB GROUP

ID: 2448

Customer Location: Hydropower plants / France
Application Date: August 2011

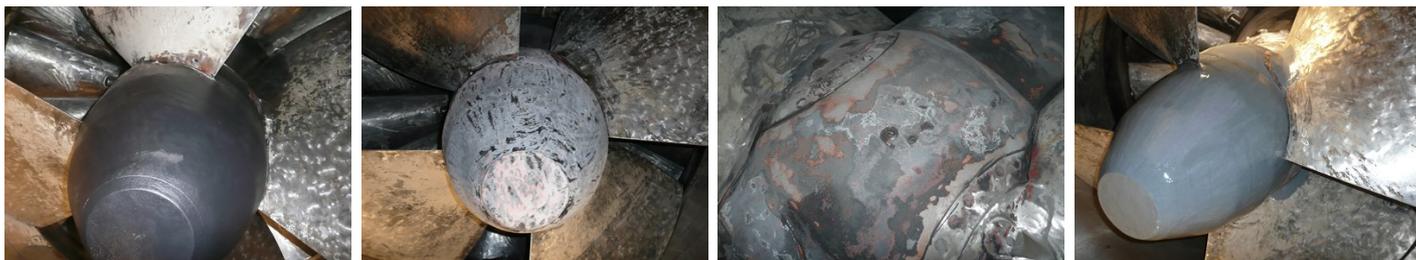
Photograph Descriptions

The hub's painting was damaged because of the engineers pinholes.

- * 1. Hub with existing painting ,
- * 2. Painting grinding to remove non-adherent parts ,
- * 3. Substrate blasting (steel and remaining painting) ,
- * 4. Completed coating with Belzona 1321 ,

The application was carried out according to the Belzona Know-How Leaflet CEP-4. After the surface preparation by grinding and blasting, a complete coating was applied in 2 coats of 250 µm on the hub.
