# BELZONA REPAIRS COLLEGE STEPS

**Industry:** Buildings & Structures  
**Application:** FPA-Floor Problem Areas  
**Substrate:** Concrete  
**Products:** \* Belzona® 4131 (Magma Screed) ,  
\* Belzona® 4411 (Granogrip) ,

**Customer Location:** College, East Midlands, UK  
**Application Date:** August 2011

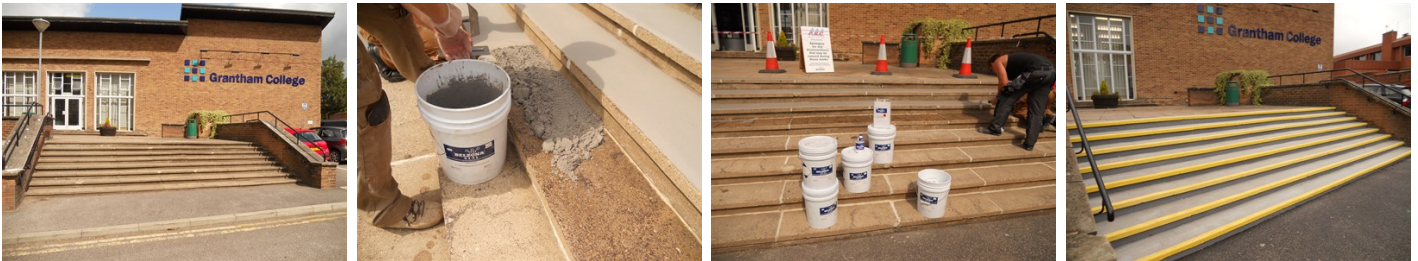
Heavy foot traffic and weathering caused the steps at this college to become damaged and worn.

- \* General view of the damaged steps ,
- \* First application of Belzona® 4131 ,
- \* Application being carried out ,
- \* Finished application ,

Application was carried out in accordance with the Belzona Know-How System Leaflets FPA-1 and FPA-8

Belzona products were required in order to give a fast, long-lasting and cost-effective repair. The ability to bond to and build up old concrete meant that the steps did not have to be completely removed and rebuilt. Belzona® 4411 was applied to the step nosings to provide a safety grip system and to ensure there was a contrast in colour, in order to meet the current DDA regulations regarding partially sighted people.
