# BELZONA REPAIRS ARMY VEHICLE

ID: 2452

**Industry:** Military  
**Application:** TCC-Tanks and Chemical Containment Areas  
**Substrate:** Cast Aluminium  
**Products:** \* Belzona® 1161 (Super UW-Metal) ,

**Customer Location:** British Army, UK  
**Application Date:** 2010

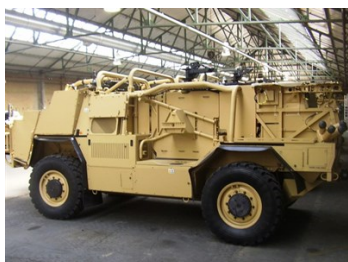
- \* The Jackal ,
- \* The porous gearbox casting before application ,
- \* The gearbox sealed with Belzona® 1161 ,

The Jackal, a high mobility army vehicle used in Afghanistan by the British Army

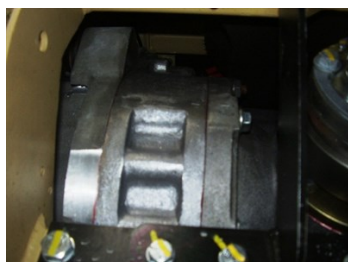
*The vehicle's gearbox casting was porous leading to unacceptable oil loss.*
