# BELZONA PROTECTS PIPELINE AND VALVES FROM CEMENT ABRASION

Industry: *Cement*  
Application: *VPF-Valves, Pipes and Fittings*  
Substrate: *steel*  
Products: *\* Belzona® 1811 (Ceramic Carbide),*

Customer Location: *Cement producer, Slovakia*  
Application Date: *2000*

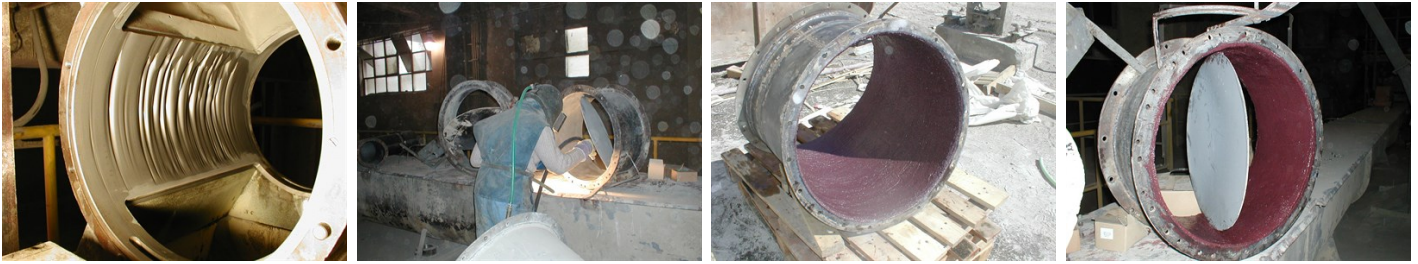
*There was high abrasion caused by cement leading to local material loss of metal from valve body.*

- \* Badly eroded valve ,
- \* Grit blasting the valves ,
- \* Completed valve body ,
- \* Re-assembled valve protected with Belzona® 1811 ,

Application was carried out in accordance with Belzona Know-How System Leaflet VPF-11.

The Belzona solution was initially accepted by customer because repair took only a few hours and the mill shut-down was very short. Since the first repairs in 2000 many more of these repairs have been completed.
