# BELZONA SEALS SKYLIGHTS OVER PRODUCTION HALL

ID: 2456

**Customer Location:** Machinery plant, Slovakia  
**Application Date:** 2006

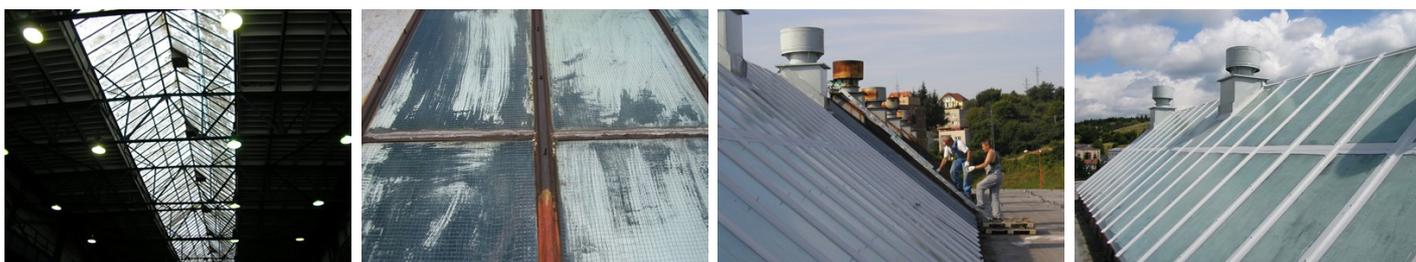
Corrosion of steel frame and rubber seal degradation on the skylights, caused by the effects of weather, was allowing rainwater to leak directly into the production hall creating safety issues and damage of interior machinery.

- \* Skylights on the production hall ,
- \* Corrosion of steel frame ,
- \* Application in progress ,
- \* The skylights in "as new" condition ,

Application was carried out in accordance with Belzona Know-How System Leaflet RPA-3. A fully reinforced Belzona® 3111 system was applied to bridge over the glazing bars and seal onto the glass.

To replace the rubber seals would take a long time and expose the interior to the full effects of the weather as well as interfering with production below. Repairs using the Belzona system was completed in 5 days without any disruption to the production process.
