# Mine locomotive axle repair

ID: 2457

Customer Location: Brown coal Mine plant, Slovakia  
Application Date: 2005

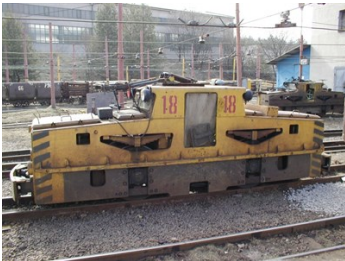
- \* 1. Mine locomotive ,
- \* 2. Failure bearing ,
- \* 3. Repair in progress ,
- \* 4. Renovated axle ,
