# Mine locomotive axle repair

ID: 2457

Industry: Mining & Quarrying  
Application: MPT-Mechanical Power Transmission

Customer Location: Brown coal Mine plant, Slovakia  
Application Date: 2005

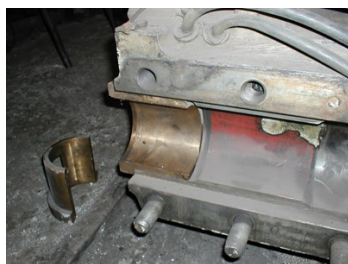
- \* 1. Mine locomotive ,
- \* 2. Failure bearing ,
- \* 3. Repair in progress ,
- \* 4. Renovated axle ,

Due the slide assembly wear of shaft axle in bronze bearing the shaft unloading appeared. Direct mark of this failure is big noise level.
