BELZONA STOPS FLOOR DRAIN LEAKS

ID: 2458

Industry: General Industry
Application: FPA-Floor Problem Areas
Substrate: stainless steel, concrete, ceramic tiles
Products: * Belzona® 4111 (Magma Quartz) ,

Customer Location: Machinery manufacturer, Slovakia
Application Date: 2008

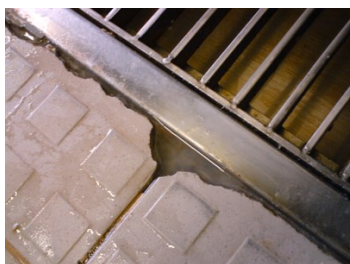
Leakage from the floor drains was problem from the start. Connection between steel and tiles was faulty. Result was the leakage to the next floor.

- * Situation before repair ,
- * Situation at the floor below ,
- * Surface preparation being carried out ,
- * Belzona® 4111 in place creating a watertight seal ,
