# BELZONA STOPS FLOOR DRAIN LEAKS

ID: 2458

**Industry:** General Industry  
**Application:** FPA-Floor Problem Areas  
**Substrate:** stainless steel, concrete, ceramic tiles  
**Products:** \* Belzona® 4111 (Magma Quartz) ,

**Customer Location:** Machinery manufacturer, Slovakia  
**Application Date:** 2008

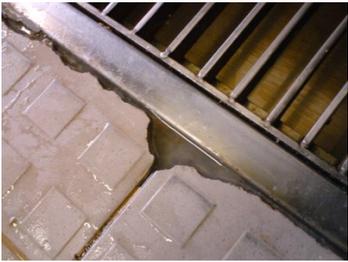
Leakage from the floor drains was problem from the start. Connection between steel and tiles was faulty. Result was the leakage to the next floor.

- \* Situation before repair ,
- \* Situation at the floor below ,
- \* Surface preparation being carried out ,
- \* Belzona® 4111 in place creating a watertight seal ,
