BELZONA REPAIRS PUMP CASINGS AND ADHERES TO ALL SURFACES

ID: 2463

Industry: *Fluid Flow*
Application: *CEP-Centrifugal Pumps*
Substrate: *Cast Iron and brass*
Products: ** Belzona 1311 (Ceramic R-Metal) ,*
** Belzona 1321 (Ceramic S-Metal) ,*

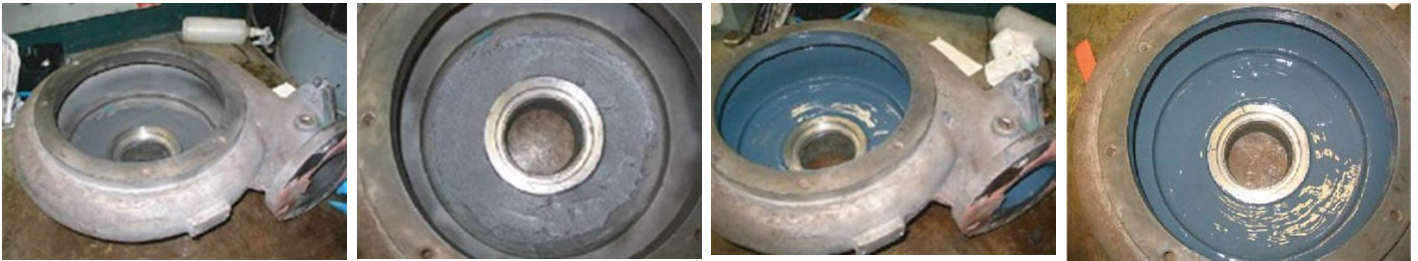
Photograph Descriptions

Cavitation around the wearing ring

- * 1. Reconstruction with Belzona 1311 (Ceramic R-Metal) ,
- * 2. View of the reconstruction. ,
- * 3. Application of Belzona 1321 (Ceramic S-Metal) to protect the pump ,
- * 4. Completed Application ,

The application was carried out in accordance with Belzona Know-How System Leaflets CEP-4 and CEP-5.

Belzona 1311 (Ceramic R-Metal) enables to repair worn sections by the cavitation effects. Moreover, it adheres perfectly to cast iron and brass.
