# BELZONA REPAIRS PUMP CASINGS AND ADHERES TO ALL SURFACES

**Industry:** Fluid Flow  
**Application:** CEP-Centrifugal Pumps  
**Substrate:** Cast Iron and brass  
**Products:** \* Belzona 1311 (Ceramic R-Metal) ,  
\* Belzona 1321 (Ceramic S-Metal) ,

**Customer Location:** Pump repair workshop, Canada  
**Application Date:** August 2005

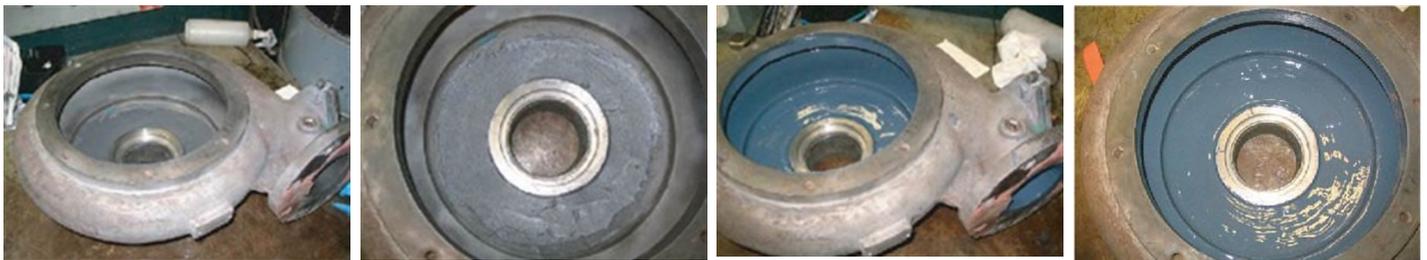
Cavitation around the wearing ring

- \* 1. Reconstruction with Belzona 1311 (Ceramic R-Metal) ,
- \* 2. View of the reconstruction. ,
- \* 3. Application of Belzona 1321 (Ceramic S-Metal) to protect the pump ,
- \* 4. Completed Application ,

The application was carried out in accordance with Belzona Know-How System Leaflets CEP-4 and CEP-5.

Belzona 1311 (Ceramic R-Metal) enables to repair worn sections by the cavitation effects. Moreover, it adheres perfectly to cast iron and brass.
