BELZONA STOPS LEAKS IN HOT WATER TANK

Industry: Sugar
 Application: TCC-Tanks and Chemical Containment Areas
 Substrate: Steel
 Products: * Belzona® 1111 (Super Metal) ,
 * Belzona® 1391 (Ceramic HT Metal) ,

Customer Location: Power Plant Ljubljana, Slovenia
 Application Date: 1997

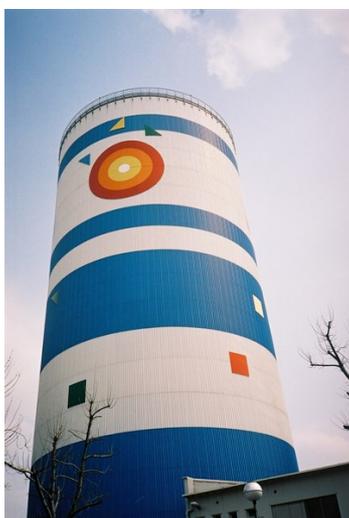
25 m diameter and 50 m high hot water tank. After initial inspection of the newly built tank, the welds connecting tank bottom steel plates were leaking.

- * Hot water tank ,
- * Applying Belzona® 1111 incorporating Reinforcement Tape ,
- * Applying Belzona® 1391 ,
- * Protected internal surface ,

Application was carried out in accordance with Belzona Know-How System Leaflet TCC-5. After reinforcing welds with Belzona® 1111 incorporating Belzona® 9341 (Reinforcement Tape), Belzona® 1391 was applied to provide corrosion protection to the whole internal bottom surface.
