BELZONA SECURES DANGEROUS WALKING AREAS

ID: 2476

Industry: Buildings & Structures
Application: FPA-Floor Problem Areas
Substrate: Tiles
Products: * Belzona® 4411 (Granogrip) ,

Customer Location: Municipal building, France
Application Date: 2004

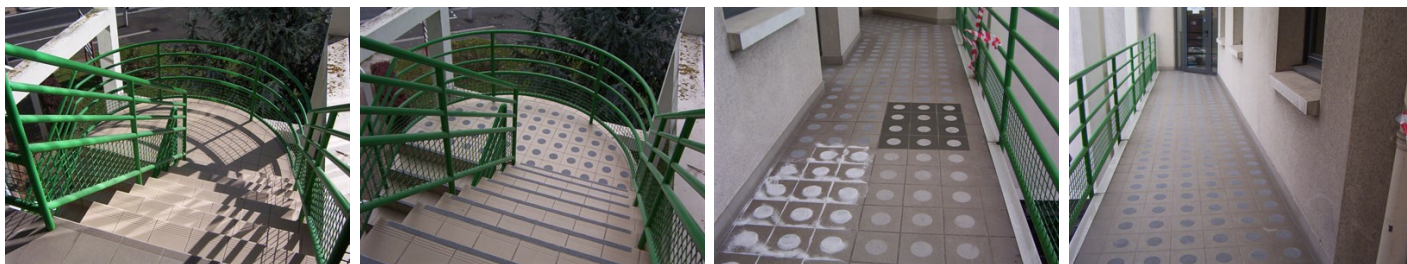
Photograph Descriptions

The stairs and walkways, located outside, were very slippery when wet.

- * The external staircase ,
- * Completed application on the stairs ,
- * Application in progress on the walkways using stencil to create pattern ,
- * Completed application on the walkway ,

The application was carried out in accordance with Belzona Know-How System Leaflet FPA-8. Belzona® 4411 was applied on stair treads and floor, using stencils to create non slip patterns on each tile.

This solution created a durable non-slip surface on the tiled floor whilst at same time presenting an aesthetically acceptable appearance.
