BELZONA SECURES THE TOWN HALL STEPS

ID: 2477

Customer Location: *Town hall, France*
Application Date: *February 2006*

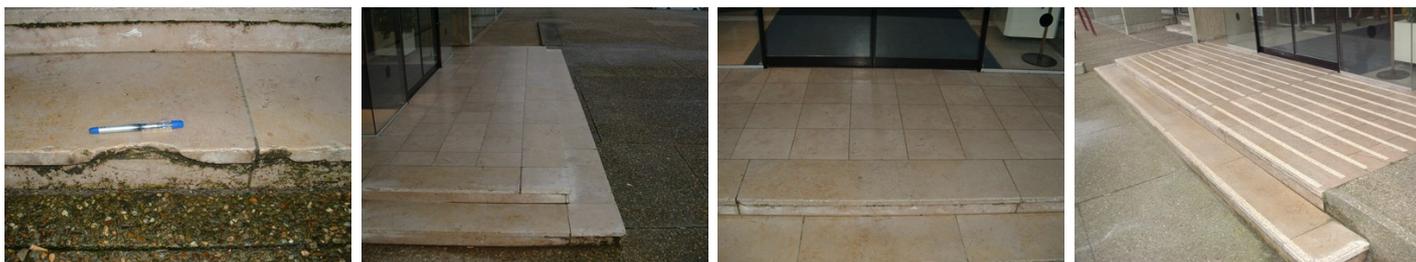
The steps were damaged through impact and were extremely slippery when wet.

- * Close view of the damaged steps ,
- * Side view of the steps ,
- * Steps rebuilt with Belzona® 4111 ,
- * Completed application with Belzona® 4411 grip system applied to leading edges ,

The application was carried out in accordance with Belzona Know-How System Leaflets FPA-8 & FPA-1. The steps were rebuilt with Belzona® 4111. A 3cm wide strip of Belzona® 4411 grip system was applied to the leading edge of the steps to create a non-slip surface.
