## BELZONA REPLACES NON-SLIP TAPES ON RAMP

ID: 2479

Industry: *Buildings & Structures*  
 Application: *FPA-Floor Problem Areas*  
 Substrate: *Travertine stone*  
 Products: *\* Belzona® 4411 (Granogrip),*

Customer Location: *Hospital, France*  
 Application Date: *February 2003*

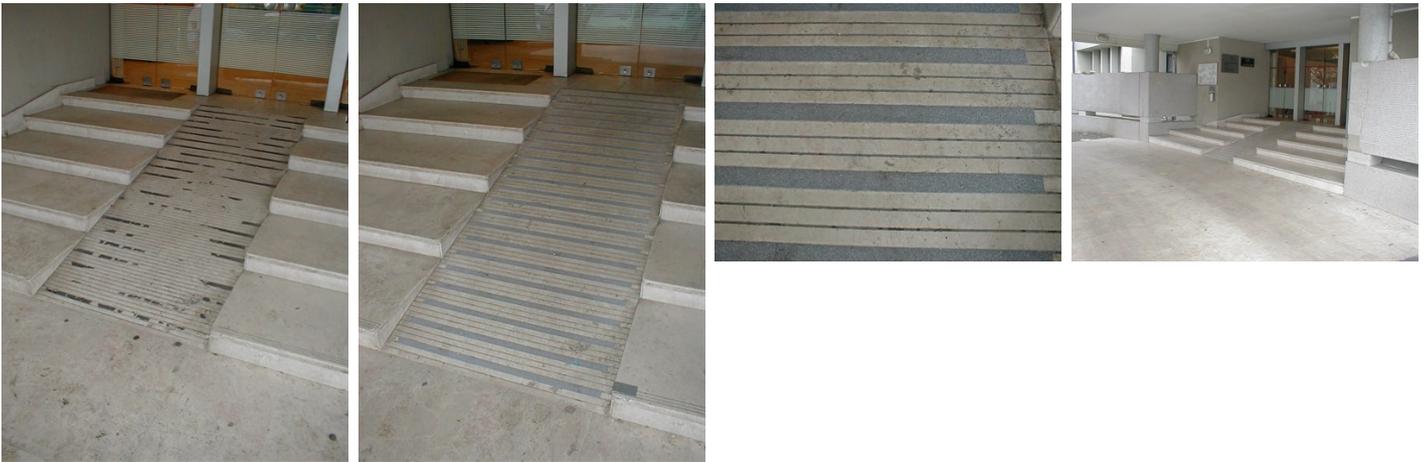
*The ramp was a potential slip hazard and adhesive tapes had been unsuccessfully used to create a non-slip surface. A more positive, long term solution was required.*

- \* Ramp with failed tape system clearly evident ,
- \* Ramp after application of Belzona® 4411 ,
- \* Close view of the application ,
- \* General view of the ramp at the hospital entrance ,

Ramp made of travertine stone.

Application was carried out in accordance with Belzona Know-How System Leaflet FPA-8.

After the application, the ramp is as new and safe for pedestrians. This application is reported to still be in perfect condition in 2012.
