BELZONA SEALS RE-DESIGNED WORKSHOP ROOF

Industry: *General Industry*
Application: *RPA-Roof Problem Areas*
Substrate: *Clad Steel Roof*
Products: ** Belzona® 3131 (WG Membrane) ,*

Customer Location: *Train operator, Newcastle, UK*
Application Date: *September 2011*

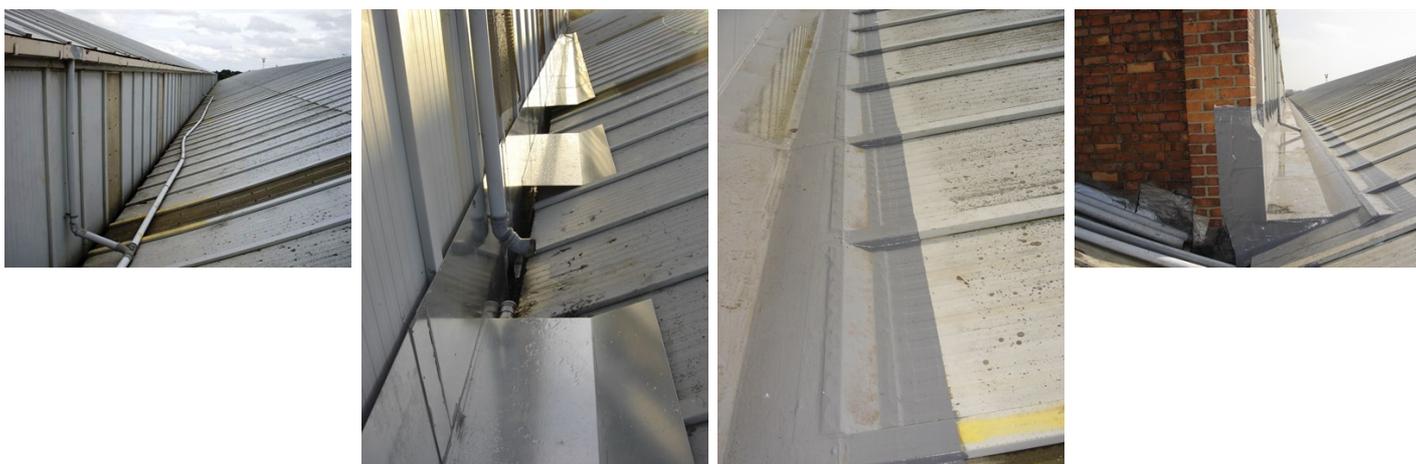
Photograph Descriptions

Heavy rainfall resulted in flooding within the workshop area. In addition, the drain pipes within the valley gutter were completely blocked.

- * Leaking Roof Area ,
- * Fabricated steel panels being installed ,
- * Belzona® 3131 applied to the panels ,
- * Total encapsulation ,

It was agreed that the rain water would be redirected into another gutter. To achieve this, panels were fabricated and riveted in place. The panels were then totally encapsulated and sealed using Belzona® 3131 applied in accordance with Belzona Know-How System Leaflet RPA-6.
