# BELZONA SEALS RE-DESIGNED WORKSHOP ROOF

ID: 2486

**Customer Location:** *Train operator, Newcastle, UK*  
**Application Date:** *September 2011*

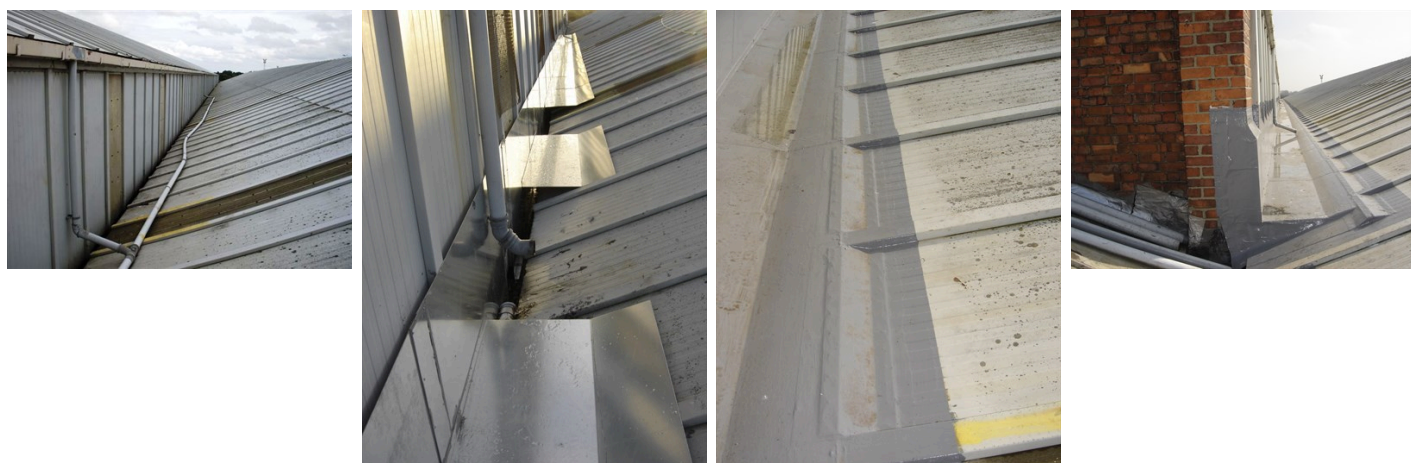
*Heavy rainfall resulted in flooding within the workshop area. In addition, the drain pipes within the valley gutter were completely blocked.*

- \* Leaking Roof Area ,
- \* Fabricated steel panels being installed ,
- \* Belzona® 3131 applied to the panels ,
- \* Total encapsulation ,

It was agreed that the rain water would be redirected into another gutter. To achieve this, panels were fabricated and riveted in place. The panels were then totally encapsulated and sealed using Belzona® 3131 applied in accordance with Belzona Know-How System Leaflet RPA-6.
