BELZONA SPECIFIED PROTECTION OF SOAP PLODDERS

Application: *SHM-Solids Handling Machinery*

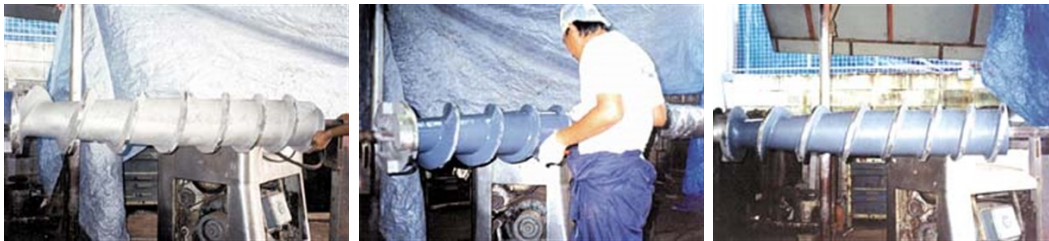
Wear and chemical attack of the worm's surface.

- * General view of plodder worm after cleaning ,
- * Application underway ,
- * Completed application ,

The application was carried out in accordance with Belzona Know-How System Leaflet SHM-14.
