# BELZONA ANCHORS NEW RUDDER BUSHES IN POSITION

ID: 253

Becker flap rudder slider bearings.

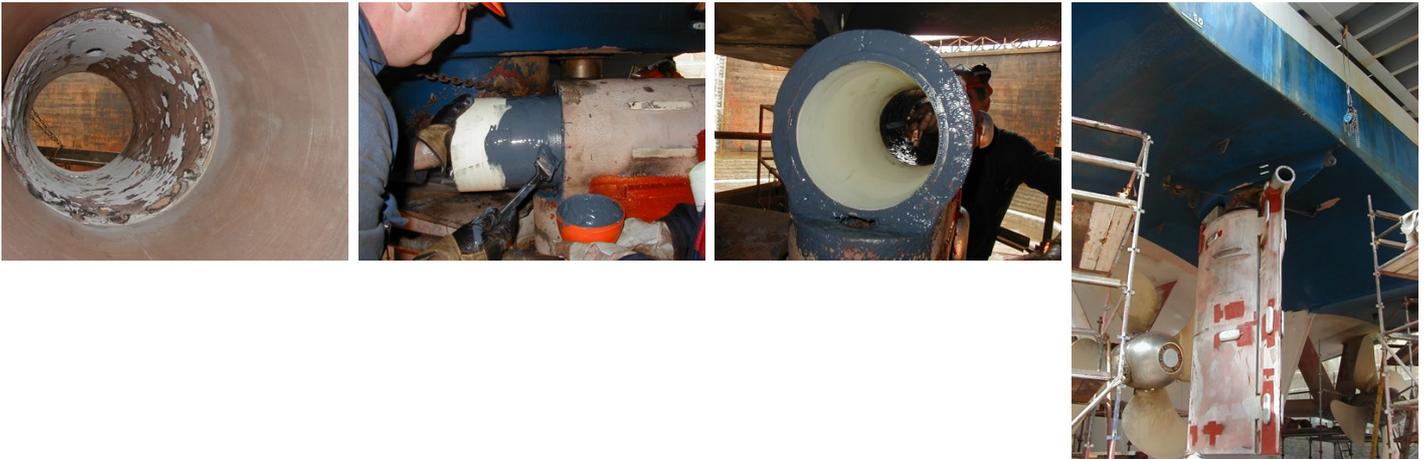
*The original bushes were bronze and had caused galvanic corrosion of the housing within one year, becoming loose.*

- \* Condition of corroded housing before repair ,
- \* Installation of the synthetic bearing, using Belzona 1321 as both adhesive and coating and "screwing" bearing into the housing ,
- \* Completed repair ,
- \* Location of the slider on top of the rudder flap ,

The application was carried out in accordance with a modified version of Belzona Know-How System Leaflet SOS-9. Belzona® 1321 functions as structural adhesive, support, and coating in this application.

This method significantly reduced the installation time and cost for bearing replacement, and extended the lifetime of the component, by eliminating future galvanic, crevice, or general corrosion from this part of the rudder. Four rudders were repaired in less than a week and Belzona is used from new to prevent these problems.
