# BELZONA BRIDGES THE GAP

ID: 255

Customer Location: Wastewater treatment plant - United Kingdom

Application: VPF-Valves, Pipes and Fittings

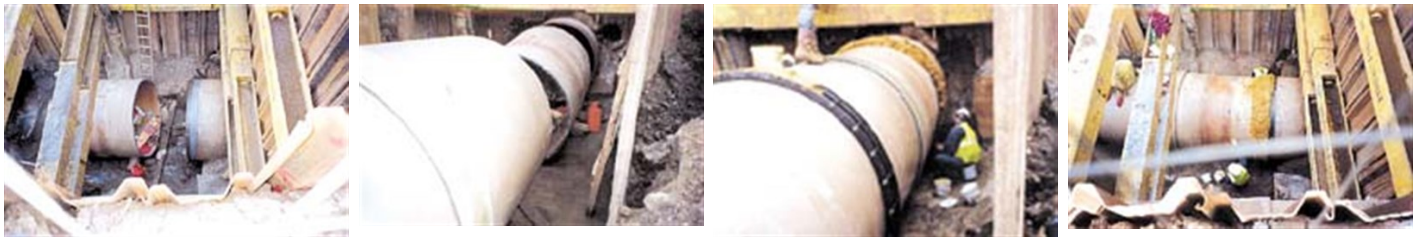
## Photograph Descriptions

Having to connect new, industrial polypropylene pipe to the old iron pipe which is severely pitted, making it impossible to obtain a water tight seal for the joint sealing ring.

- \* Overhead view of both old and new pipe before repair and connection ,
- \* The sections of pipes that were to be connected ,
- \* Run the pipes with connecting collars, following Belzona repair ,
- \* Completed repair ,

Due to restricted and muddy working conditions it was not possible to allow machinery to be used for this repair, therefore a hand-held angle grinder was used to prepare the surface. The Belzona® 1111 (Super Metal) made a smooth collar around the pipe thus providing a watertight seal.
