PRESS ROLL REPAIR WITH BELZONA

ID: 2557

Customer Location: Pulp and paper mill, Germany
Application Date: July 2008

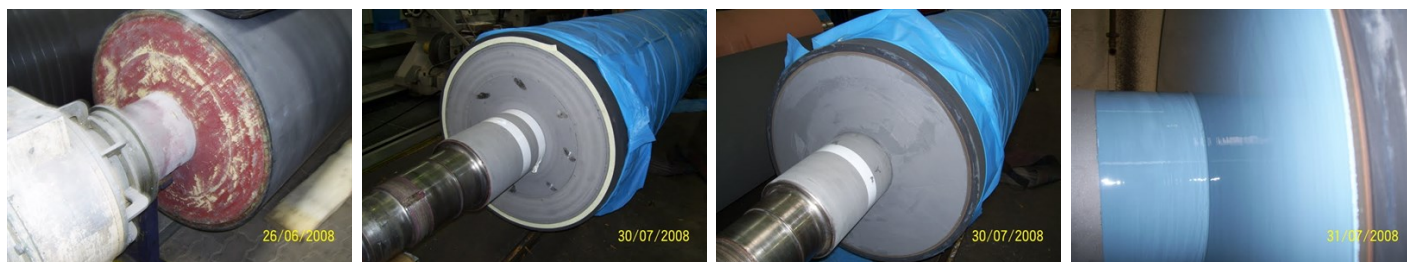
Photograph Descriptions

Corrosion had led to perforation of side plates.

- * Corroded side plate ,
- * Grist-blasted side plate ,
- * Application of Belzona® 1111 ,
- * Completed application ,

Application was carried out in accordance with Belzona Know-How System Leaflet TCC-5. The side plate was first rebuilt using Belzona® 1111. Once hard enough, two coats of Belzona® 1341 were applied to achieve a final coating thickness of 500 µm.
