# BELZONA HELPS KEEP THIS POWER PLANT ON-LINE

Industry: Power  
Application: MPT-Mechanical Power Transmission

Customer Location: Power plant in eastern Kansas, U.S.A.  
Application Date: Winter 2000

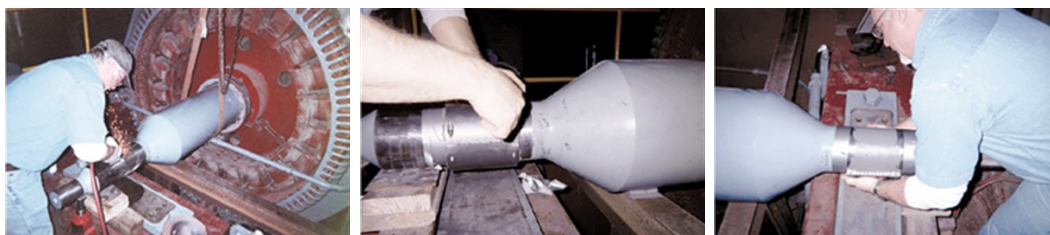
A bearing seizure damaged the armature shaft in fuel generator.

- \* Surface preparation ,
- \* The former is being tightened ,
- \* The former is removed ,

Damaged armature shaft.

The application was carried out in accordance with Belzona Know-How System Leaflet MPT-2.

Belzonas famous in place split former repair used less than \$50 worth of material and saved this company thousands of dollars in repair costs and downtime.
