BELZONA HELPS KEEP THIS POWER PLANT ON-LINE

ID: 257

Industry: *Power*
Application: *MPT-Mechanical Power Transmission*

Customer Location: *Power plant in eastern Kansas, U.S.A.*
Application Date: *Winter 2000*

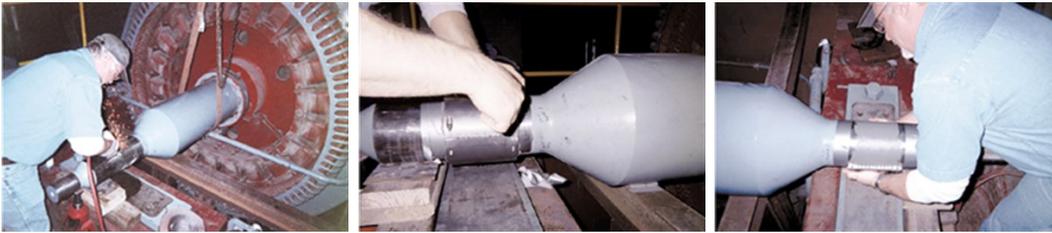
Photograph Descriptions

A bearing seizure damaged the armature shaft in fuel generator.

- * Surface preparation ,
- * The former is being tightened ,
- * The former is removed ,

Damaged armature shaft.

The application was carried out in accordance with Belzona Know-How System Leaflet MPT-2.

Belzonas famous in place split former repair used less than \$50 worth of material and saved this company thousands of dollars in repair costs and downtime.
