BELZONA REPAIRS A CLASSIFIER AND SAVES THE CUSTOMER THOUSANDS IN REPLACEMENT COSTS

Customer Location: Water Treatment Plant - New Mexico
U.S.A.

Application: SHM-Solids Handling Machinery

Solids classifier in the grit removal system.

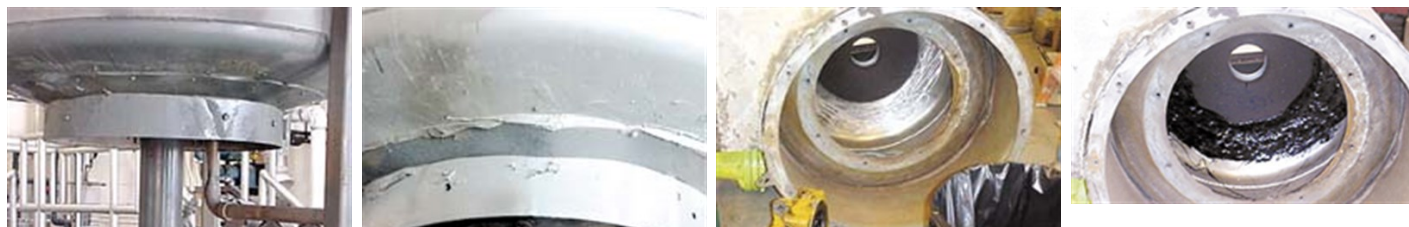
Photograph Descriptions

The rubber donut type ring was designed too small allowing the adjacent steel to wear through.

- * An overview of the equipment ,
- * A close-up of the damage ,
- * The surface is being prepared ,
- * The completed repair ,

Belzona® 1111 (Super Metal) was used to bond several steel patches where the steel had worn through. Then Belzona® 2111 (D&A Hi-Build Elastomer) was used to re-create a durable donut replacement. Alternatives included replacement of equipment at \$14,000 each. Welding would have ruined the existing rubber donuts. The Belzona Solution was only \$600 for each classifier.
