# BELZONA REPAIRS A CLASSIFIER AND SAVES THE CUSTOMER THOUSANDS IN REPLACEMENT COSTS

ID: 258

Customer Location: Water Treatment Plant - New Mexico  
U.S.A.

Application: SHM-Solids Handling Machinery

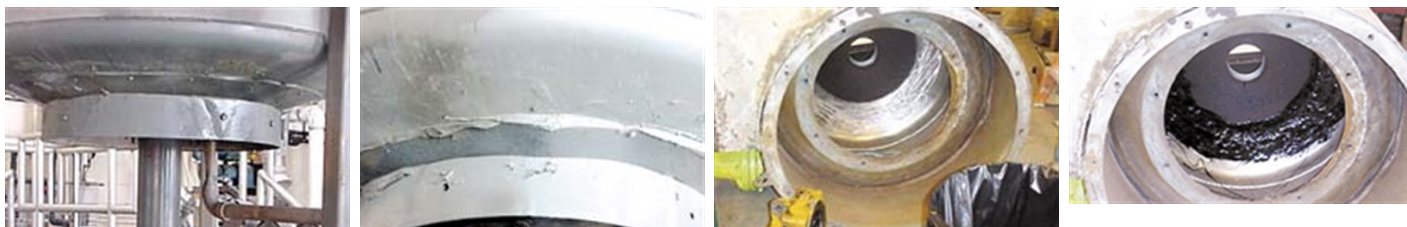
The rubber donut type ring was designed too small allowing the adjacent steel to wear through.

- \* An overview of the equipment ,
- \* A close-up of the damage ,
- \* The surface is being prepared ,
- \* The completed repair ,

Belzona® 1111 (Super Metal) was used to bond several steel patches where the steel had worn through. Then Belzona® 2111 (D&A Hi-Build Elastomer) was used to re-create a durable donut replacement. Alternatives included replacement of equipment at \$14,000 each. Welding would have ruined the existing rubber donuts. The Belzona Solution was only \$600 for each classifier.
