BELZONA RESTORES ARCHIMEDES SCREW

Customer Location: Wastewater treatment facility in a chemical plant, Florida U.S.A.

Application: SHM-Solids Handling Machinery

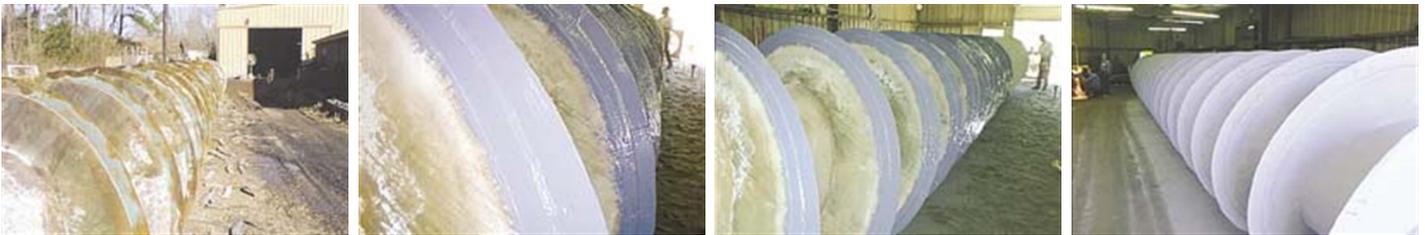
Photograph Descriptions

Corrosion/erosion caused the screw blades to wear down. The diameter of the angle was reduced so much that it could not lift the water.

- * Damaged Archimedes screw ,
- * A close look of welded outskirts coated with Belzona® 1321 ,
- * Entire screw edges were coated with Belzona ,
- * Completed application with cosmetic coating applied ,

The application was carried out in accordance with a modified version of Belzona Know-How System Leaflet SHM-14.

The screw blade edges were worn down and the protective fiberglass liner had delaminated. After welding blade extensions all the way around, Belzona® 1321 was used to reinforce existing fiberglass liner, protecting the entire new weld.
