# LIFT STATION WET WELL STAYS IN SERVICE WITH HELP FROM BELZONA

**Customer Location:** Central Lift Station in West Palm Beach, Florida U.S.A.

**Application:** TCC-Tanks and Chemical Containment Areas

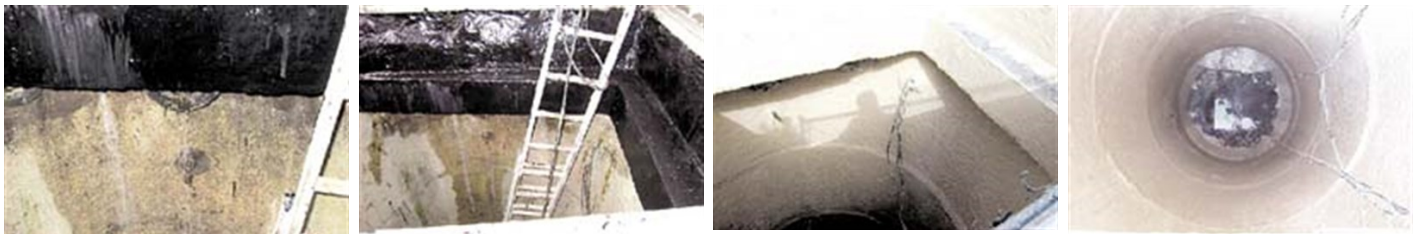
Hydrogen sulfide attack deteriorated the concrete in the wet well area of a lift station.

- \* Deteriorated concrete surface with water penetration from outside ,
- \* First coat of Belzona® 5811 has been applied to the concrete surface ,
- \* Second coat on the upper section of the wet well ,
- \* Completed job ,

Severely damaged concrete surfaces above the sewer level were rebuilt with Belzona® 4141 and the entire internal surface of the lift station wet well was protected by two coats of Belzona® 5811. The Belzona Solution offered minimal downtime and long term protection against hydrogen sulfide attack.
