BELZONA® 5811 REPEAT TANK APPLICATION

ID: 264

Customer Location: *Aluminium producer in Holland*
Application Date: *1993 and February 2001*

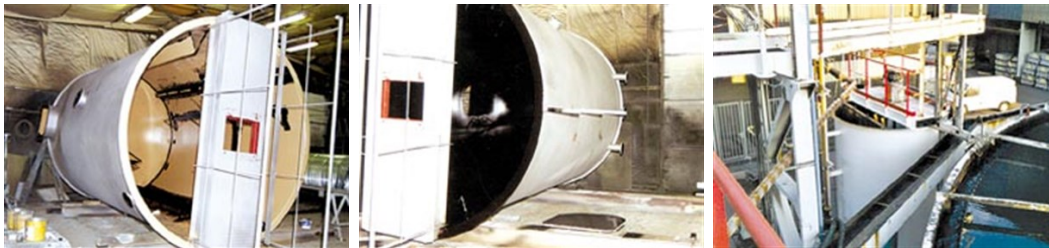
Photograph Descriptions

- * The first coat of Belzona® 5811 (beige) applied and details being stripe coated ,
- * Second coat of Belzona® 5811 (black) applied ,
- * Tank re-installed in original position ,

The application was carried out in accordance with Belzona Know-How System Leaflet TCC-5. After stripe coating welds, brackets and other awkward areas. The Belzona® 5811 was applied by heated airless spray.

Belzona® 5811 originally applied to tank in 1993 was still in excellent condition. However, the tank had corroded on the outside between base and concrete so a new tank had to be fabricated. The client had no hesitation in specifying Belzona® 5811 again.
