BELZONA SUPERWRAP IN A REFINERY

ID: 2689

Customer Location: Refinery, France
Application Date: March 2010

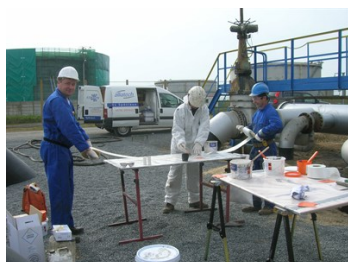
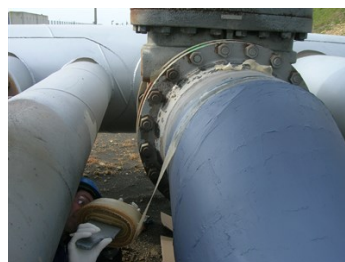
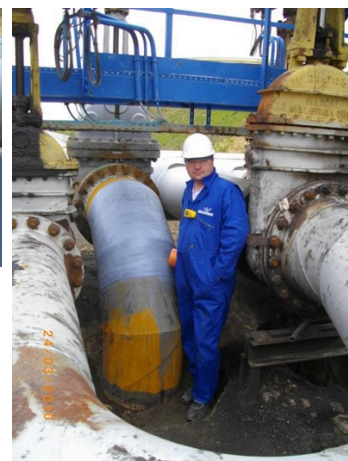
Photograph Descriptions

Corrosion occurs where the buried section of pipeline re-emerges above ground. The high humidity at ground level causes severe corrosion to these exposed sections of the pipeline.

- * General view of the Refinery ,
- * Preparation ,
- * Application in progress ,
- * Completed repair ,

Belzona® SuperWrap system installed in compliance with the requirements of ISO/TS 24817 and ASME PCC-2.
