# BELZONA SUPERWRAP IN A REFINERY

ID: 2689

Customer Location: Refinery, France  
Application Date: March 2010

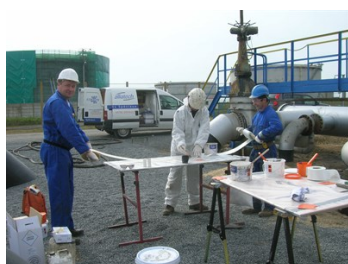
- \* General view of the Refinery ,
- \* Preparation ,
- \* Application in progress ,
- \* Completed repair ,

Belzona® SuperWrap system installed in compliance with the requirements of ISO/TS 24817 and ASME PCC-2.
