BELZONA SUPERWRAP IN A REFINERY

ID: 2689

Customer Location: Refinery, France
Application Date: March 2010

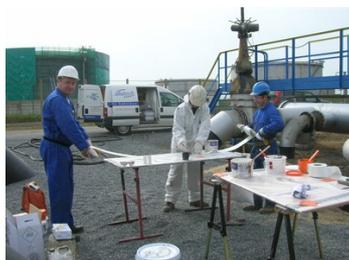
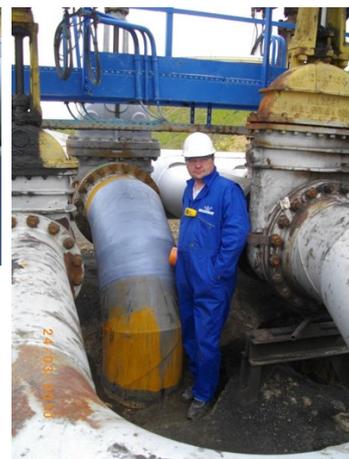
Photograph Descriptions

Corrosion occurs where the buried section of pipeline re-emerges above ground. The high humidity at ground level causes severe corrosion to these exposed sections of the pipeline.

- * General view of the Refinery ,
- * Preparation ,
- * Application in progress ,
- * Completed repair ,

Belzona® SuperWrap system installed in compliance with the requirements of ISO/TS 24817 and ASME PCC-2.
