# BELZONA REPAIRS KAPLAN TURBINE BLADES IN FRANCE

**Industry:** Power  
**Application:** CEP-Centrifugal Pumps  
**Substrate:** Cast iron  
**Products:** \* Belzona® 1111 (Super Metal) ,  
\* Belzona® 1341 (Supermetalgilde) ,

**Customer Location:** Electric supply company in France  
**Application Date:** February 2000

Kaplan turbine hydroelectric power station on the Moselle River in France.

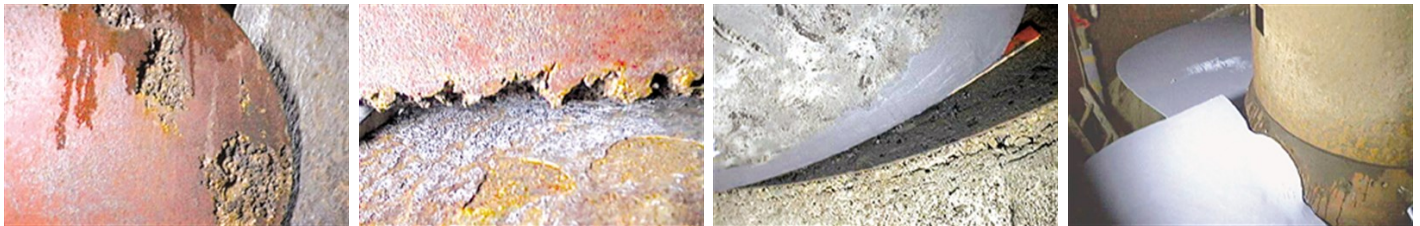
*Erosion-corrosion of the blades leading to large loss in efficiency. In particular, cavitation had caused deep erosion in localized areas.*

- \* Cavitation-erosion damage present on the turbine blades ,
- \* The blade edges were particularly badly eroded ,
- \* Blade profiles being restored with Belzona® 1111, using plastic strips to obtain edge detail ,
- \* Completed application. Note the smooth surface obtained with Belzona® 1341 ,

The application was carried out in accordance with a modified version of Belzona Know-How System Leaflets CEP-1 and CEP-10. The blade edges were rebuilt using plastic formers to accurately restore the required profiles.

After one year in service, the Belzona System was inspected and was found in excellent condition. Although no accurate measure of efficiency was available, the Belzona System will restore the original efficiency and provide power production through its smooth, hydrophobic surface.
