THAT'S ONE BIG ROOF APPLICATION WITH BELZONA

Customer Location: *Olympic Complex, Algeria*

Application: *RPA-Roof Problem Areas*

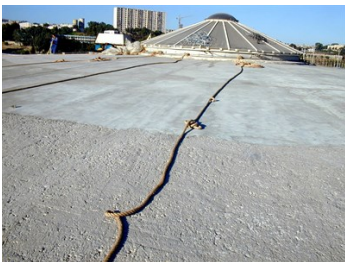
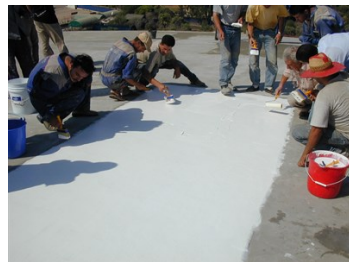
Photograph Descriptions

Corrosion and weather damage had caused the 12,000m² roof of the Olympic Complex to leak.

* Damaged concrete roof Application of Belzona® 3111 Completed application in 2003 Revisited application in 2014 ,

Application was carried out in accordance with Belzona Know-How System Leaflet RPA-1. Firstly the asbestos coating inside the dome was removed. The roof was resurfaced using a cement based screed to provide a good base for the new coating. A fully reinforced Belzona® 3111 system was then applied.

The Application was revisited in 2009. After 6 years in service, there was no deterioration of the roof structure. The coating, although covered in dust following a dust storm, was still in an excellent condition underneath. The coating still provided UV-resistance and was watertight.
